Manhole Inspection Summary

Manhole # S15II2011MH

Location Address: **1810 KENWAY RD**

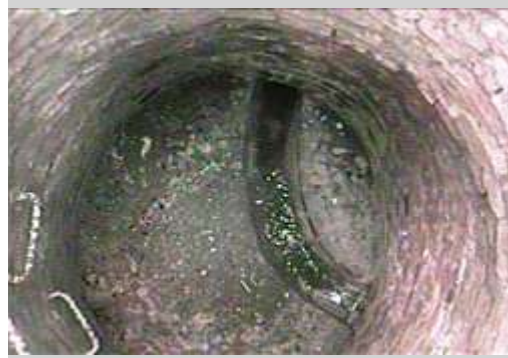
Top View

Bench and Channel debris.

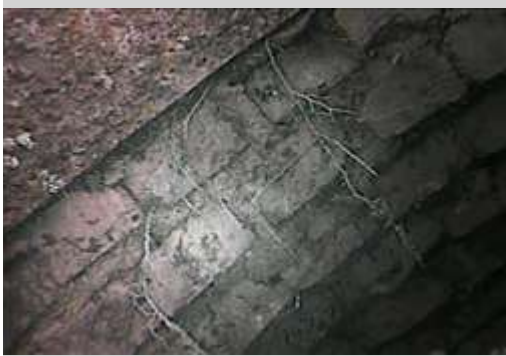
Defect

Condition: ☐ Sound ☐ Cracked ☒ **Root Intrusion** ☐ Loose Brick ☒ **Deteriorated**

Infiltration: ☐ None ☒ **Joint** ☐ Cracks ☒ **Mortar** ☒ **Roots** ☐ Wall

Infiltration: ☐ None ☐ Joint ☐ Cracks ☒ **Mortar** ☐ Roots ☒ **Wall**

Adjustment deterioration, root intrusion, and infiltration. Corbel infiltration.

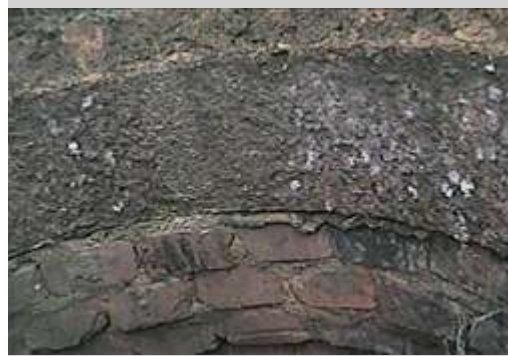
Defect

Adjustment deterioration, root intrusion, and infiltration.

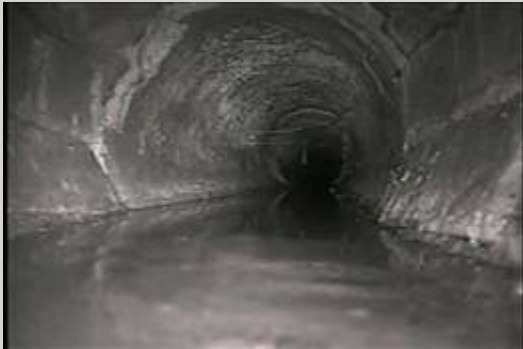
8 in. Circular Gravity Sewer Pipe Out @ 12 O'Clock

Deposits: ☐ None ☐ Mud ☐ Sludge ☐ Debris ☒ Grease

Silt Depth: **0** (in.) Deposits Extent: **Light**

Infiltration: **Evidence** Pipe Seal Cond: **Cracked**
